CHAPTER	TABLE OF CONTENTS	PAGE
	Background	1
1	Existing Facilities	3
2	Planning Methodology	15
3	Planning Concepts	19
4	Master Plan	23
5	Design Criteria	27
6	Initial Phase	33
7	Construction Schedule	37
8 F	Planning Team - Long Range Planning Committee	38

Southwest Texas Junior College is a public, tri-county state supported community college district composed of Real, Uvalde, and Zavala Counties. The main campus is located in Uvalde, Texas with additional outreach centers in Del Rio and Eagle Pass, Texas. The main campus is adjacent Garner Field Airport and occupies the site that originally housed the Army Air Force Flying School from 1942-1945.

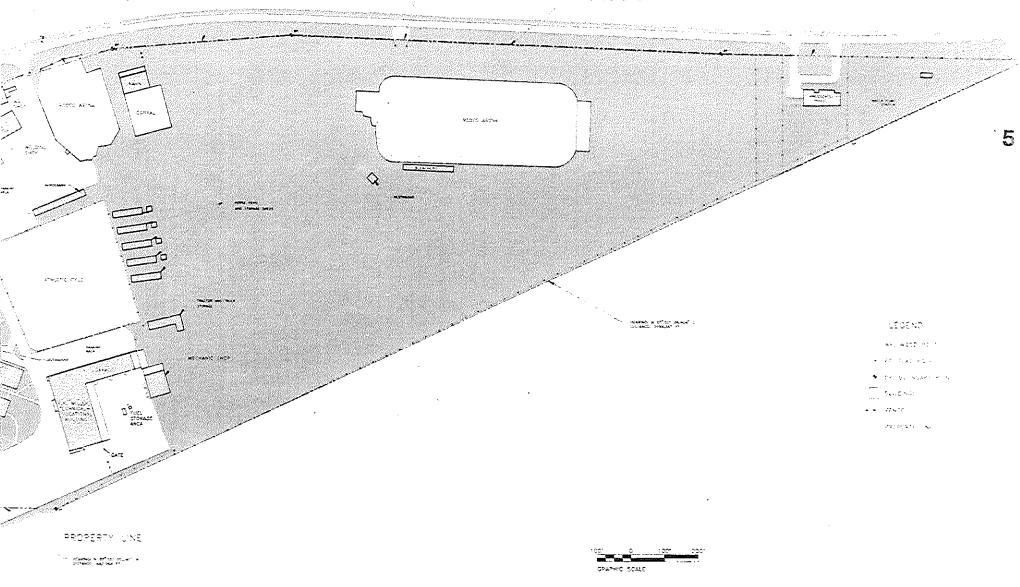
# **EXISTING FACILITIES**

The physical plant of the college is defined by a loop road system that encloses the majority of the structures. The landscaping within the inner circle is very well maintained providing an excellent setting for an educational institution. Automobile parking is primarily outside of the loop facilitating pedestrian movement between buildings. The buildings are one or two floors with brick exterior. A large portion of the campus is allocated to horse facilities - there are two arenas, barns, and numerous animal pens and storage facilities.

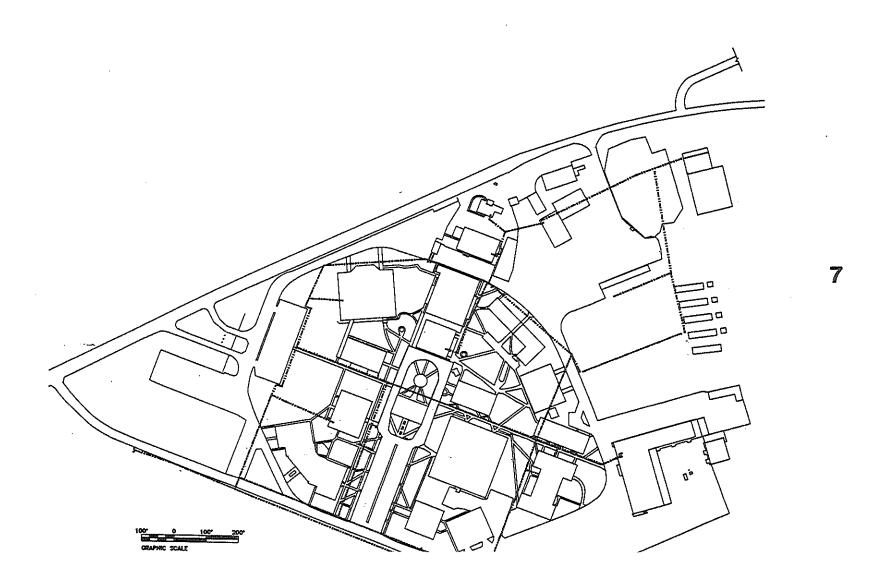
# EXISTING WATER PLAN

EXISTING FACILITIES: The infrastructure of the campus, particularly the water system, is in need of replacement. Fire protection is marginal and does not meet any criteria for the protection of the buildings or students. On-site testing is required to determine the condition of the fuel storage facility. However, regardless of its own condition, its age causes concern. The campus buildings as a whole have been well maintained, but do require some repairs and deferred maintenance.

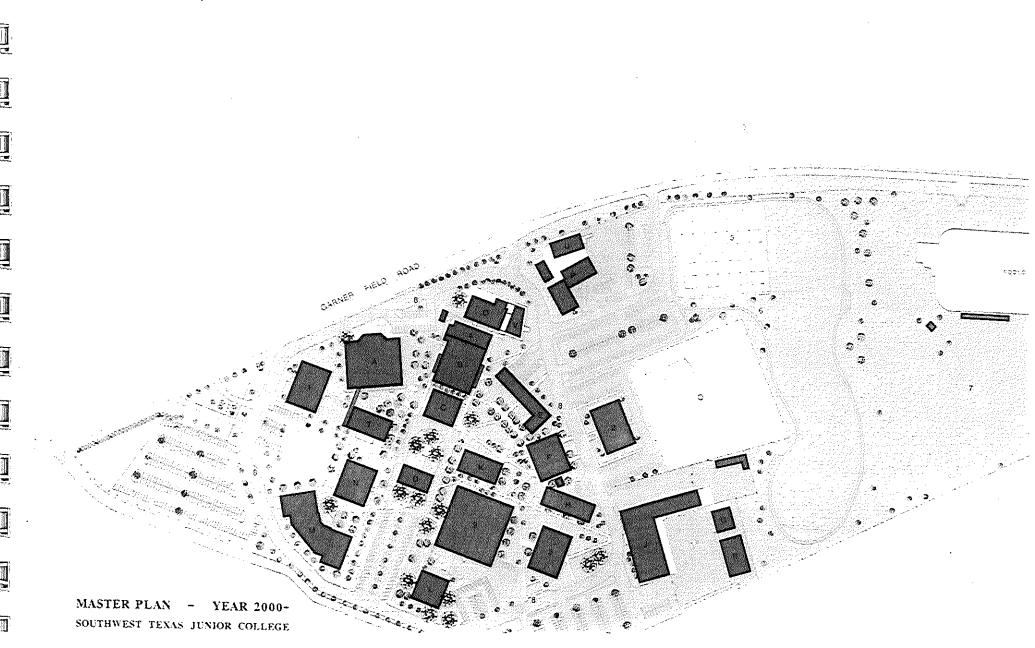
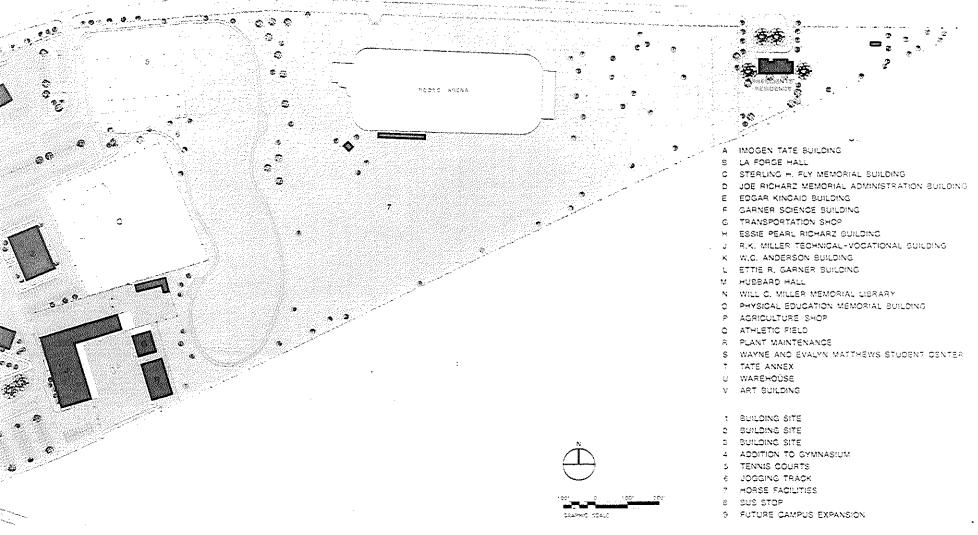
#### MASTER PLAN - YEAR 2000+

The Master Plan for the campus provides a comprehensive solution which establishes a pattern of growth from now until beyond the year 2000. During this planning period the college should purchase some additional land to facilitate an adequate vehicular circulation pattern, to provide additional automobile parking, and to assure the availability of future building sites. The proposed plan identifies some new building sites and provides the framework for the creation of a positive, identifiable edge for the college. The Plan organizes parking and provides the pedestrian convenient access to the

buildings. The campus interior is to remain a pedestrian zone similar to the prevailing atmosphere of the existing campus.

Generally, the Plan enhances the present good features of the college and eliminates or neutralizes the institution's negative characteristics. It is envisioned that the present loop circulation street pattern will be retained and enhanced to allow for two way traffic. A key feature of the Master Plan is to develop and feature the school's main entrance and to establish an identifiable edge to the campus.

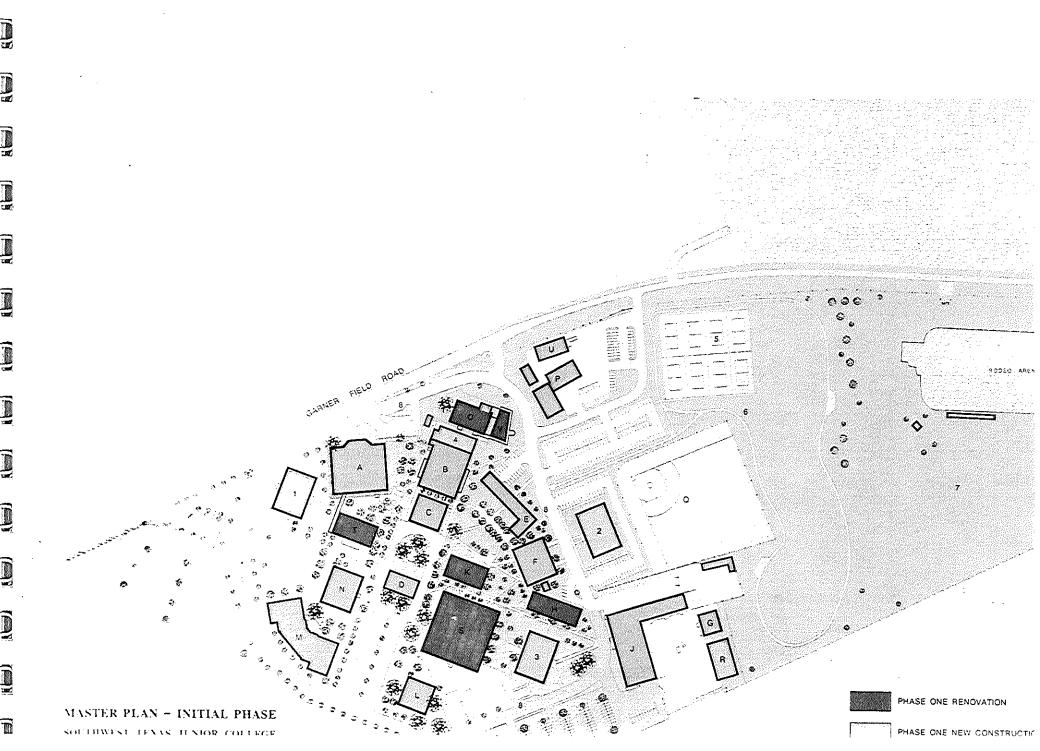
# MASTER PLAN - INITIAL PHASE

The basic infra-structure of the college will benefit initially with the replacement of the school's water lines and fire protection system. The relocation of the Maintenance Building will trigger the relocation and improvement of facilities for the art, math, science, and cosmetology programs. Other programs to receive facility alterations include law enforcement, police academy, aviation, nursing, business, and aquatics. In addition the first phase work will include enhancement of auto-

mobile parking areas, mechanical and plumbing work for the Matthews Student Center, and the installation of new fuel tanks.

The later part of the Initial Phase will be completed with the construction of a new class-room building to house the college's business administration courses and faculty and other related facilities. This building will be located near the college's main entrance.
