CAMPUS: Uvalde

NAME OF BUILDING: Joe Richarz Administration

Building Area: 10,000 Sq. Ft. No. of floors: 2
 Original Construction Date 1961
 Additions None

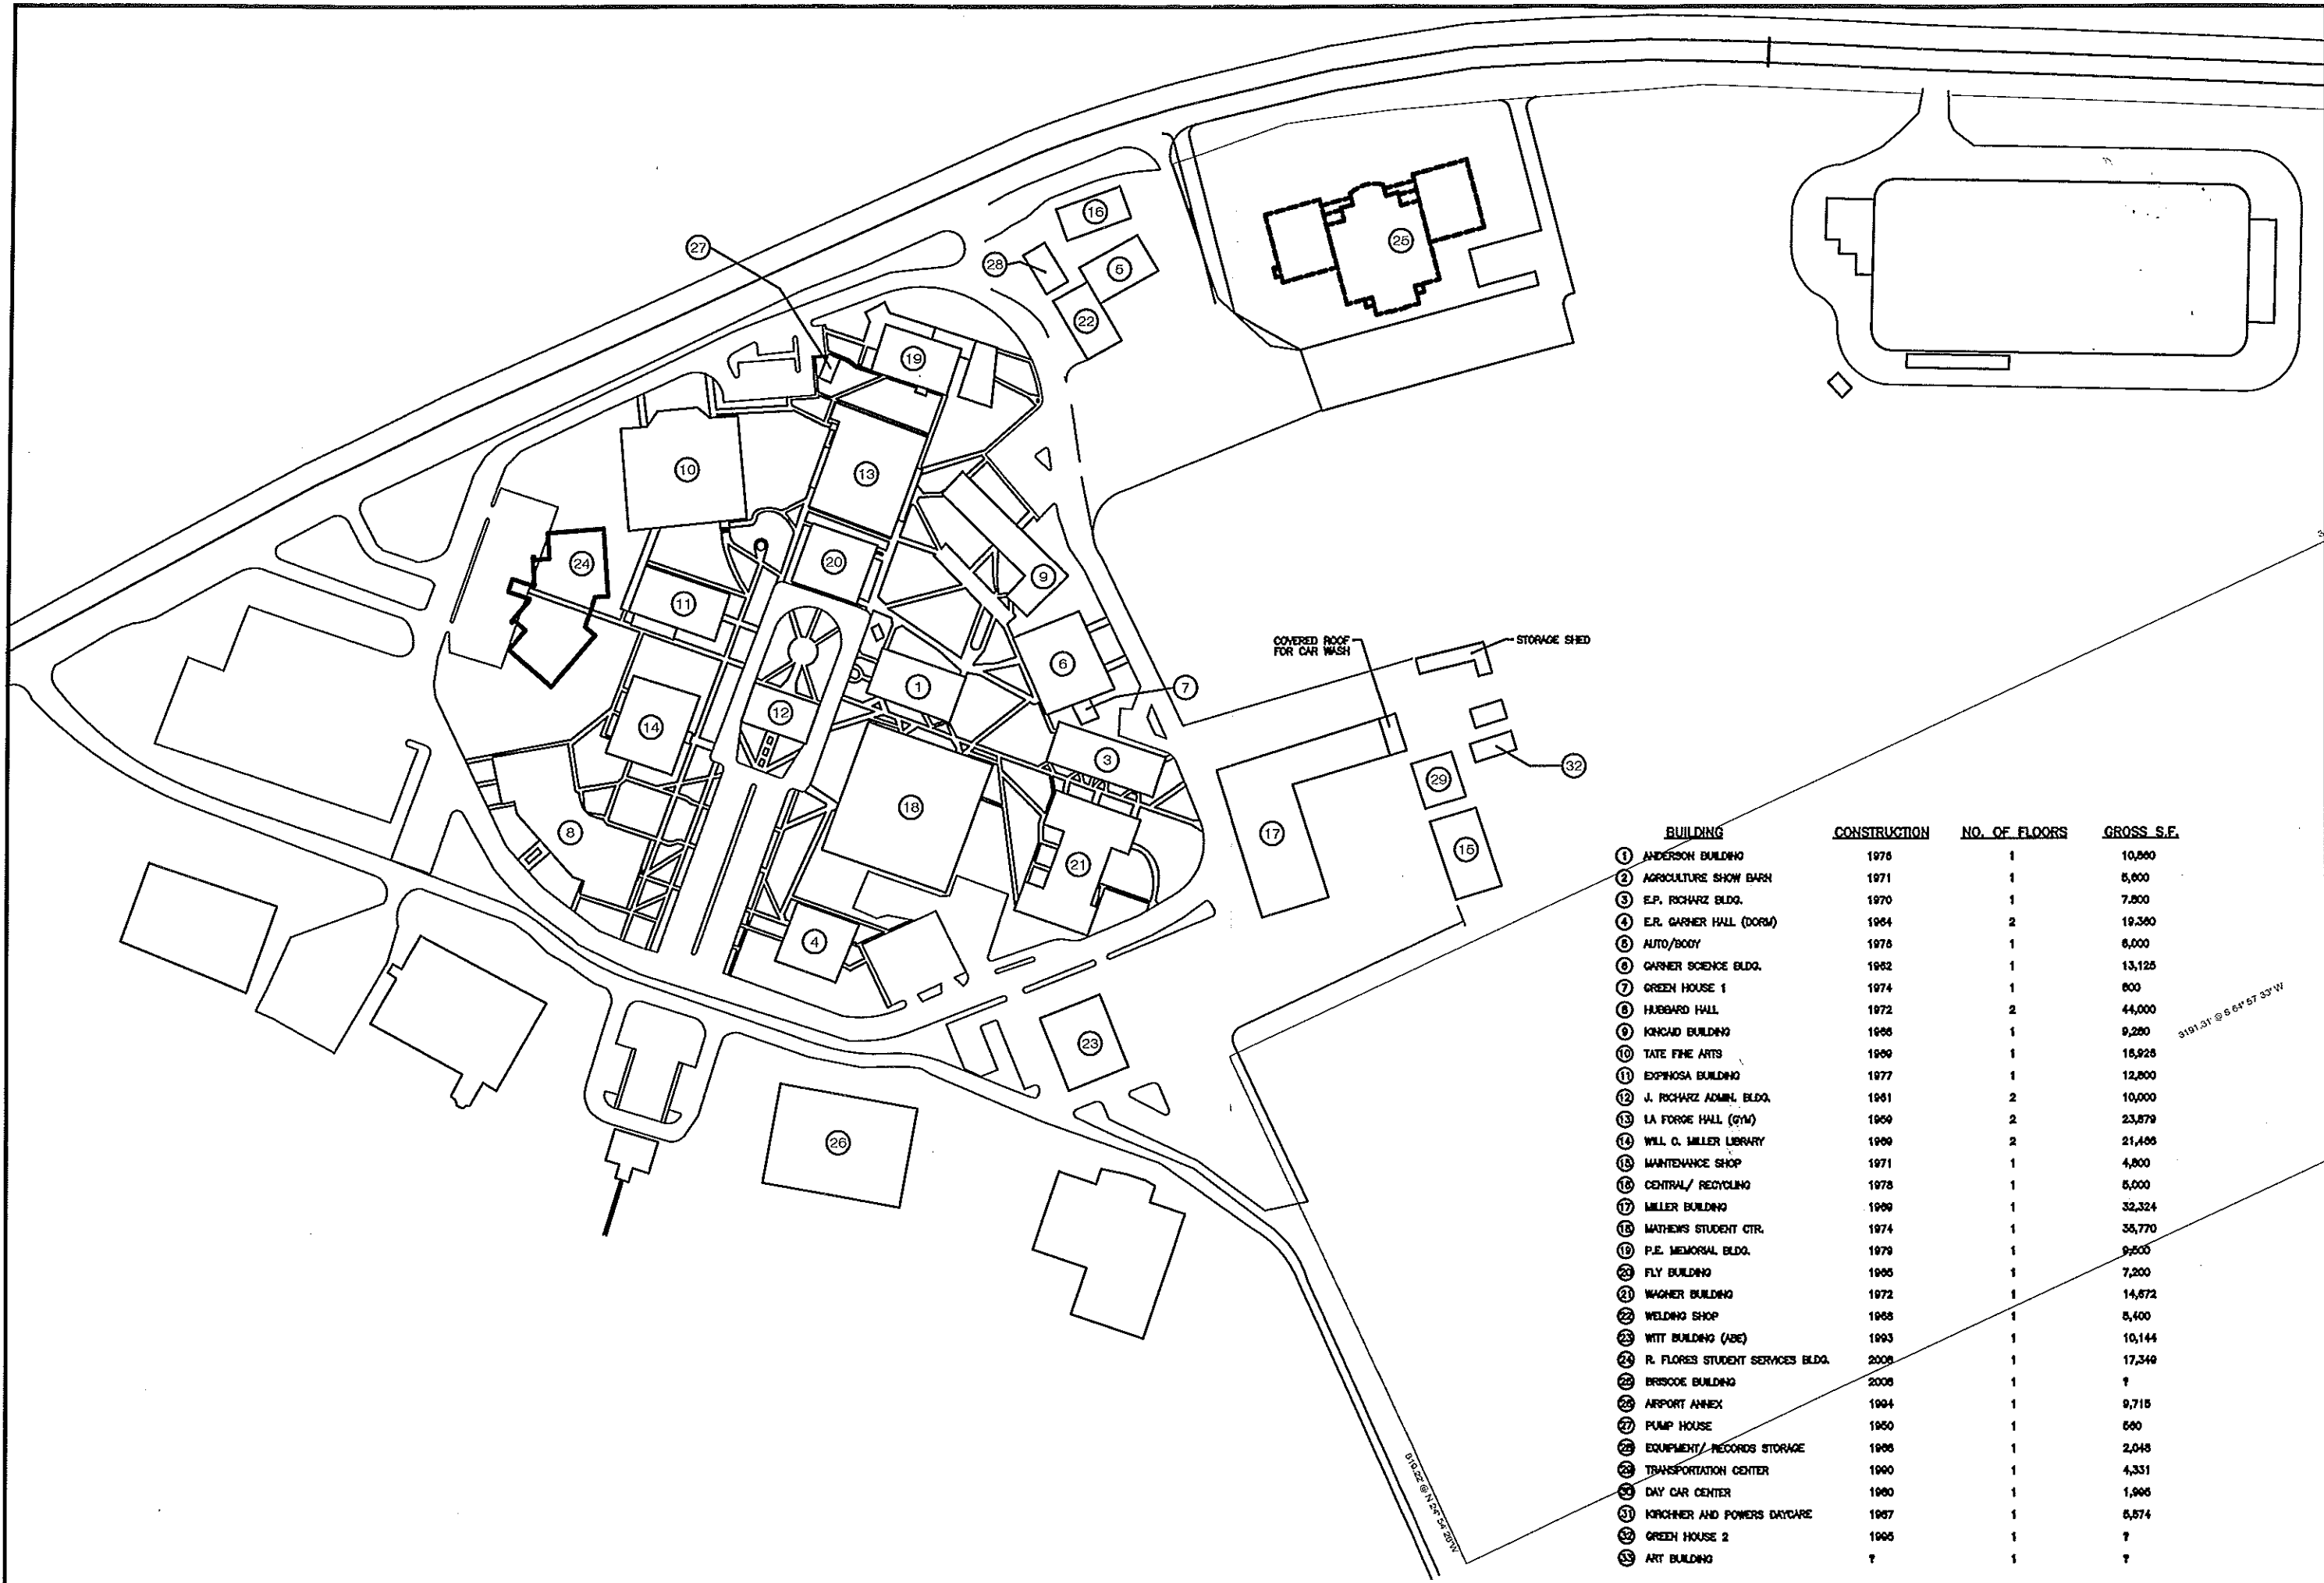
BUILDING	CONSTRUCTION	NO. OF FLOORS	GROSS S.F.
① ANDERSON BUILDING	1976	1	10,860
② AGRICULTURE SHOW BARN	1971	1	5,600
③ E.P. RICHARZ BLDG.	1970	1	7,800
④ E.R. GARNER HALL (DORM)	1964	2	19,360
⑤ AUTO/BOOY	1976	1	6,000
⑥ GARNER SCIENCE BLDG.	1962	1	13,125
⑦ GREEN HOUSE 1	1974	1	800
⑧ HUBBARD HALL	1972	2	44,000
⑨ KIRCAD BUILDING	1966	1	9,280
⑩ TATE FINE ARTS	1969	1	18,928
⑪ EXPINOSA BUILDING	1977	1	12,800
⑫ J. RICHARZ ADMIN. BLDG.	1961	2	10,000
⑬ LA FORGE HALL (GYM)	1969	2	23,879
⑭ WILL C. MILLER LIBRARY	1969	2	21,486
⑮ MAINTENANCE SHOP	1971	1	4,800
⑯ CENTRAL/ RECYCLING	1978	1	6,000
⑰ MILLER BUILDING	1969	1	32,324
⑱ MATHEWS STUDENT CTR.	1974	1	35,770
⑲ P.E. MEMORIAL BLDG.	1979	1	9,500
⑳ FLY BUILDING	1966	1	7,200
㉑ WAGNER BUILDING	1972	1	14,672
㉒ WELDING SHOP	1968	1	5,400
㉓ WITT BUILDING (ABE)	1993	1	10,144
㉔ R. FLORES STUDENT SERVICES BLDG.	2006	1	17,349
㉕ BRISCOE BUILDING	2006	1	?
㉖ AIRPORT ANNEX	1994	1	9,715
㉗ PUMP HOUSE	1950	1	600

㉘ EQUIPMENT/ RECORDS STORAGE	1966	1	2,048
㉙ TRANSPORTATION CENTER	1990	1	4,351
㉚ DAY CAR CENTER	1980	1	1,966
㉛ KIRCHNER AND POWERS DAYCARE	1987	1	6,574
㉜ GREEN HOUSE 2	1965	1	?
㉝ ART BUILDING	?	1	?
